## Inspector's Daily Report

IDR Sheet 1 of	Sheets
Contract C-7852	Day Thursday	Date August 5, 2010

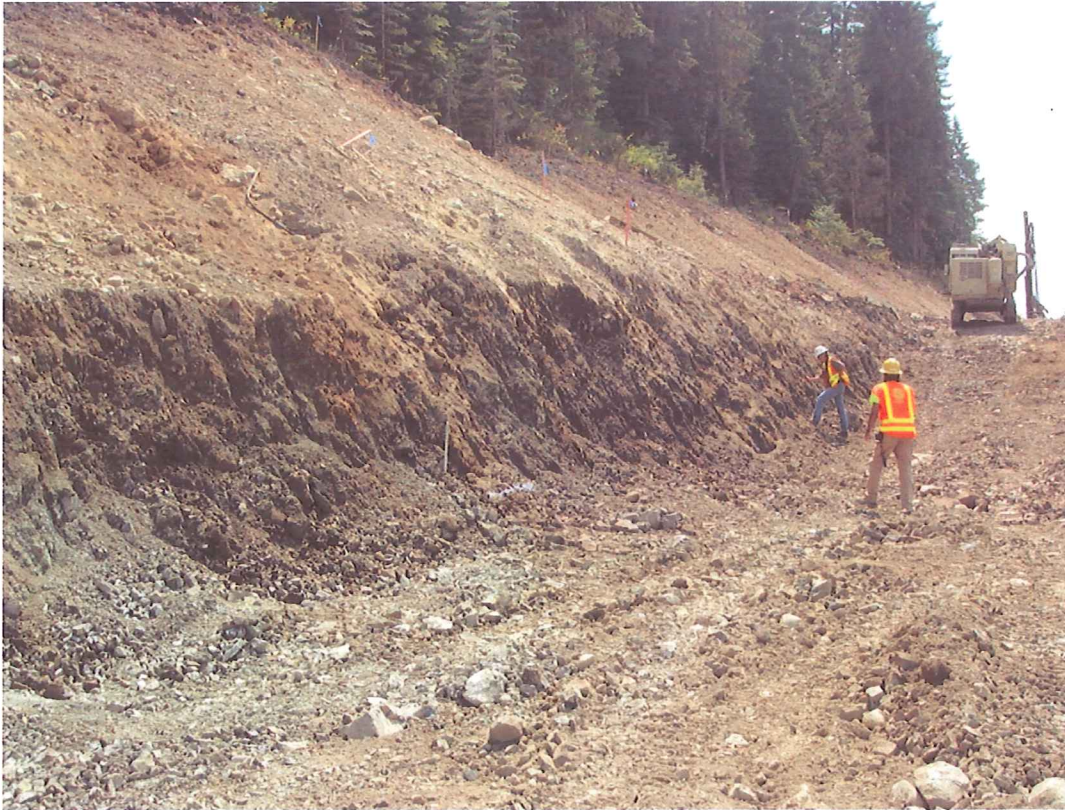
We examined the newly exposed, upper 12 feet of the lift roughly between Stations 1318+50 and 1320+50 (Figure 1). The rock mass consisted of very closely fractured (thin platy fracture), reddish brown to dark gray, highly altered/weathered aphanitic basalt (or possibly argillite). We observed very few preshear holes in the excavated face. We did not observe any adversely oriented, persistent discontinuities that would influence cut stability, but the highly fractured and somewhat dilated nature of the exposed rock that would indicate a long-term stability issue for at least shallow instability of the 0.5H:1V cut. Western State drillers indicated this very poor quality rock likely persists for the full depth of the lift. Drill cuttings from the preshear holes being drilled at Station 1320+50 were light greenish gray in color (with a noted exception of reddish brown cuttings between Stations 1321+75 to 1322+00), suggesting that rock quality should improve ahead on station. We told Brad that we were not prepared to provide recommendations for this newly exposed area without first conferring with Steve and Norm, but that additional stabilization work might be needed for this area. I spoke with Steve, and he asked that we ask the contractor to drill several exploratory drill holes into the face to probe for the extent of this poor quality zone. The contractor was not able to complete this prior to our leaving, due to equipment difficulties. We plan to review existing geotechnical data and then determine the necessity for additional investigation (possibly geotechnical borings). We will be performing additional stability analyses based on the

Figure 1A. Recently excavated lift between Stations 1319+00 and 1320+50.

existing information to determine the need, extent, and type of additional stabilization. The contractor need not be delayed while we evaluate this area and develop our recommendations. If we determine that additional stabilization is needed, this work will likely have to be done after the excavation work is completed.

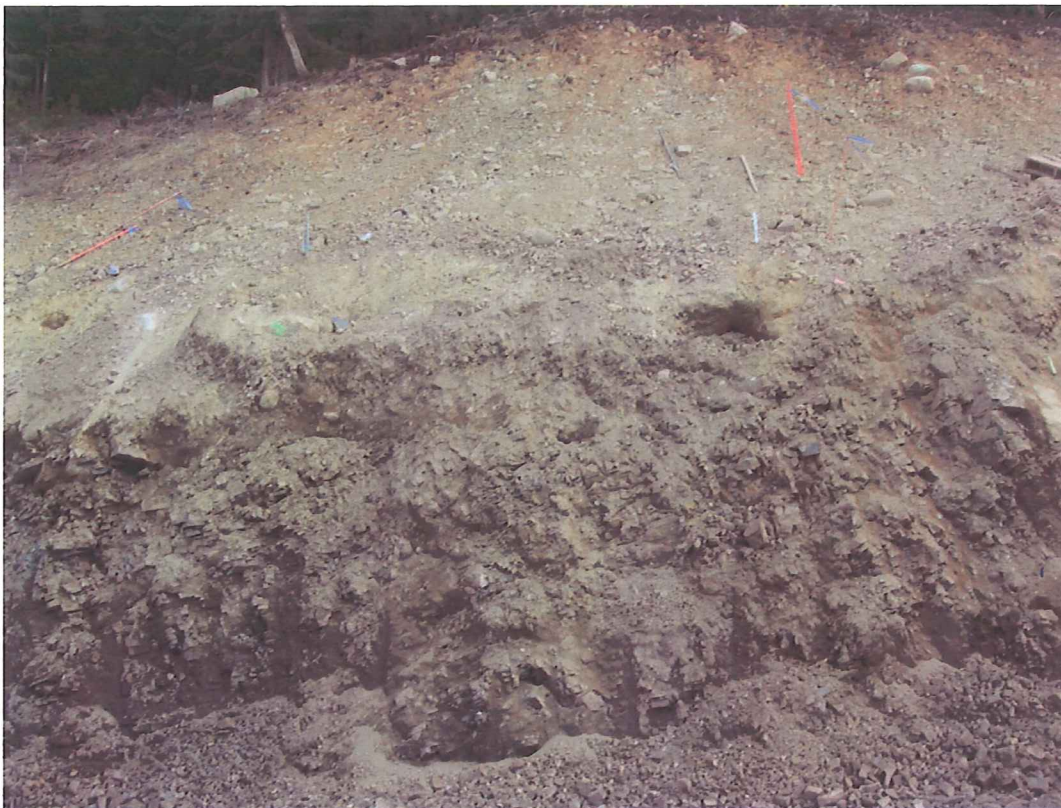
Figure 1B. View of highly altered, basalt (argillite?) with very closely spaced fractures.

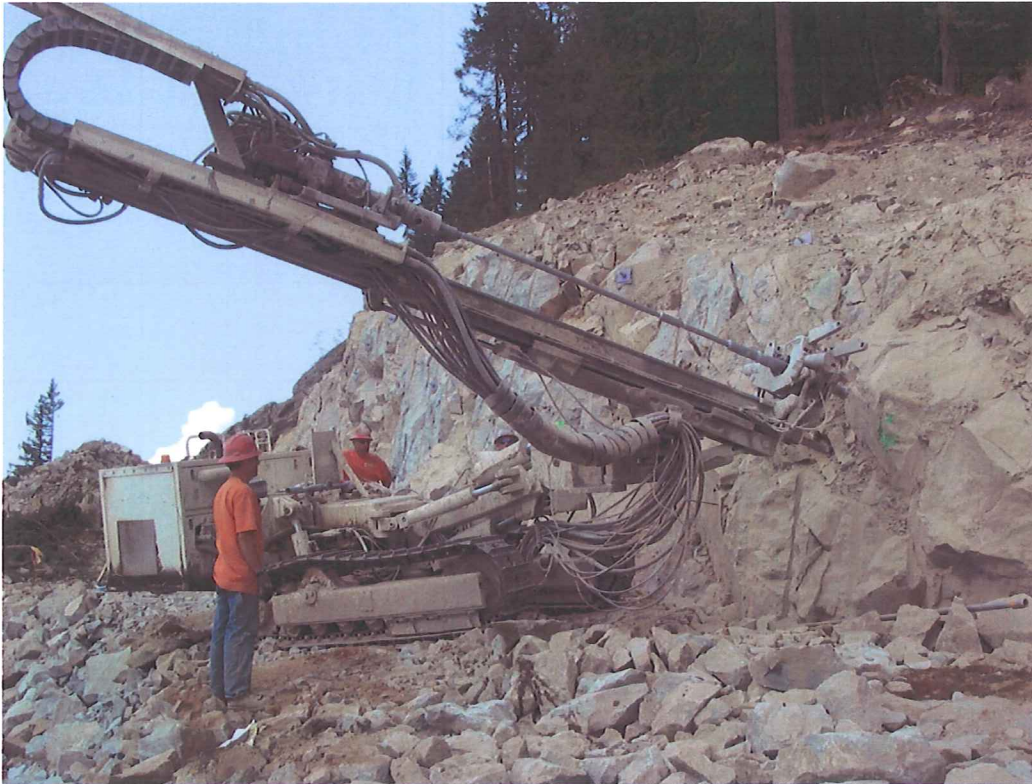
Figure 2. NW Cascade's drill for rock dowels/bolts. Note that the boom is not fully extended horizontally or vertically, indicating higher reach capacity.

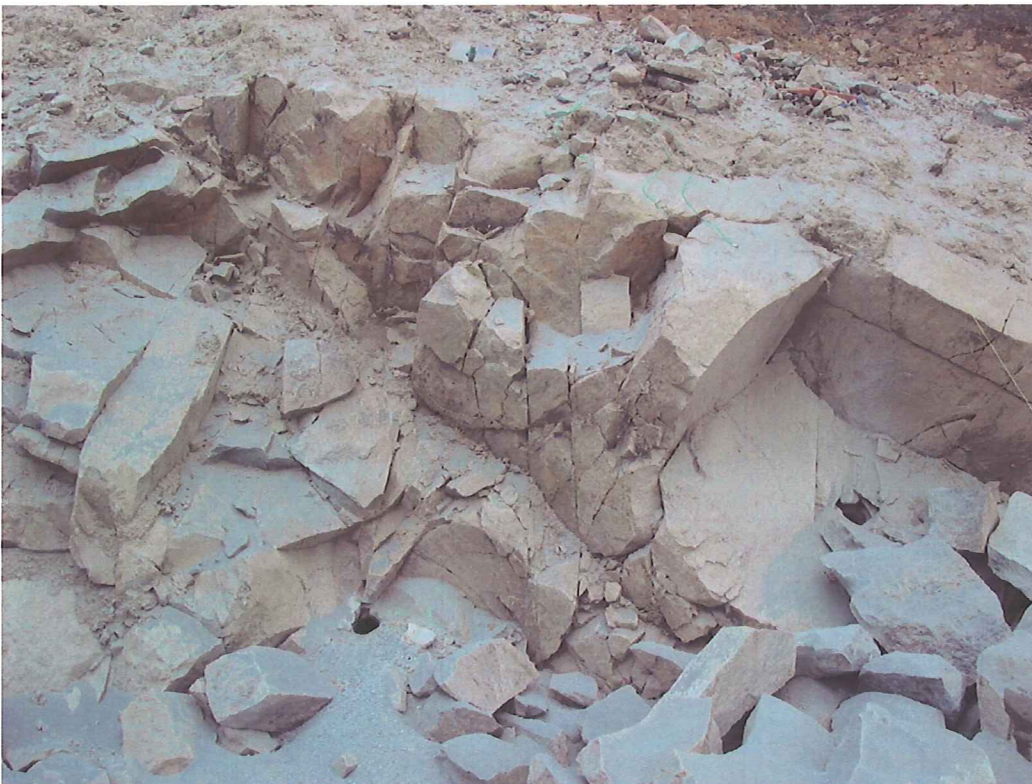
At Station 1338, the contractor had built a 5 to 10 ft high bench out of shot rock to provide a bench for NWC drilling of dowels and Type L bolts. The contractor was drilling anchor locations at least 6 ft above the bench with no apparent access difficulties, except for the chuck tender who was climbing on the drill mast for access (Figure 2). Around the 2 easternmost anchors, several small (~2-3 cubic yard) failures had occurred around the drill hole collars (Figure 3). We recommended that very light machine scaling (or preferably hand scaling) be done to clean up the remaining loose rocks. Some additional short dowels may be needed for this area, but could be installed at a later date with lightweight drill equipment, to avoid further damage to the face. We would examine this area again after the loose rock was removed, and determine what, if any, additional reinforcement was needed.

Figure 3. Small slope failures around Station 1338 around drill holes for rock anchors.
